Project Summary

Hydroelectric Facility Northeastern, New York

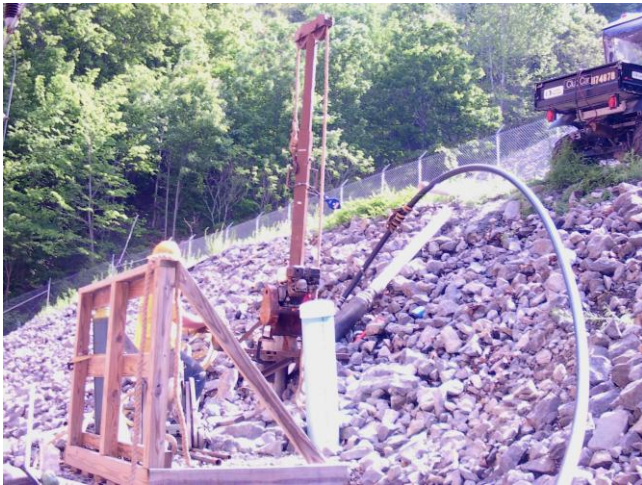
Three relief wells had been installed at this hydroelectric facility to control the hydrostatic head along a steep slope at the site. The relief wells were constructed with 8-inch diameter stainless steel well materials with multiple screened zones. Artesian conditions exist and the wells flow naturally to a common discharge point. Bio-fouling of the screens had reduced the flows from the wells such that they were not effectively controlling the hydrostatic head.

An initial evaluation of each of the three relief wells was performed which consisted of video logging the wells, conducting step drawdown tests and collecting groundwater samples for geochemical analyses. Following a review of the acquired data the wells were re-developed using a combination of surging and pumping via an air-lift pump. Chemical additives were utilized to enhance the re-development activities. Subsequent to the re-development activities a video log and step drawdown test was performed at each well to document the improvement to well conditions. Special equipment and an attention to safety were paramount.
